AIMS Materials Science, 3(3): 832-850.

Research article

Effect of hygrothermal conditioning on the mechanical and thermal properties of epoxy grouts for offshore pipeline rehabilitation

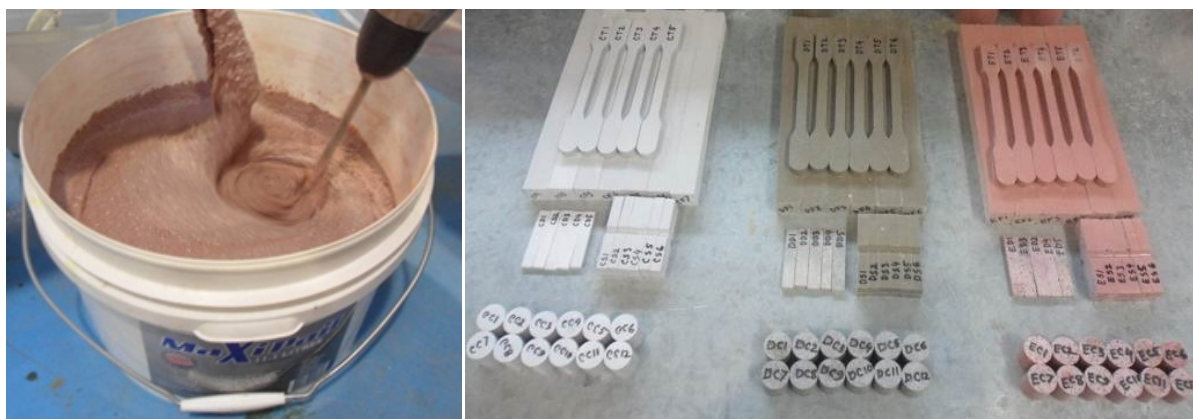
Figure 1. Preparation of specimens. (a) mixing of the grouts and (b) part of typical test specimens.

Respective parts of the grout systems were mixed volumetrically and by weight according to the guidelines stated in the respective Technical Data Sheets. A hand held electric drill mixer was used to mix the volumetric batch in a plastic container. Freshly mixed grouts were poured into moulds within their respective allowable mixing periods at 23 °C. Freshly mixed grouts were poured into the designated moulds. Figure 1 shows the mixing of typical grout EG3 and part of the grout specimens. The specimens were cut and polished to the required dimensions. Table 2 summarises the details of specimen dimensions and tests conducted on the prepared specimens. The specimens were removed from the moulds after 24 hours and cured in a controlled environment at 23°C for 7 days prior to hot-wet conditioning.

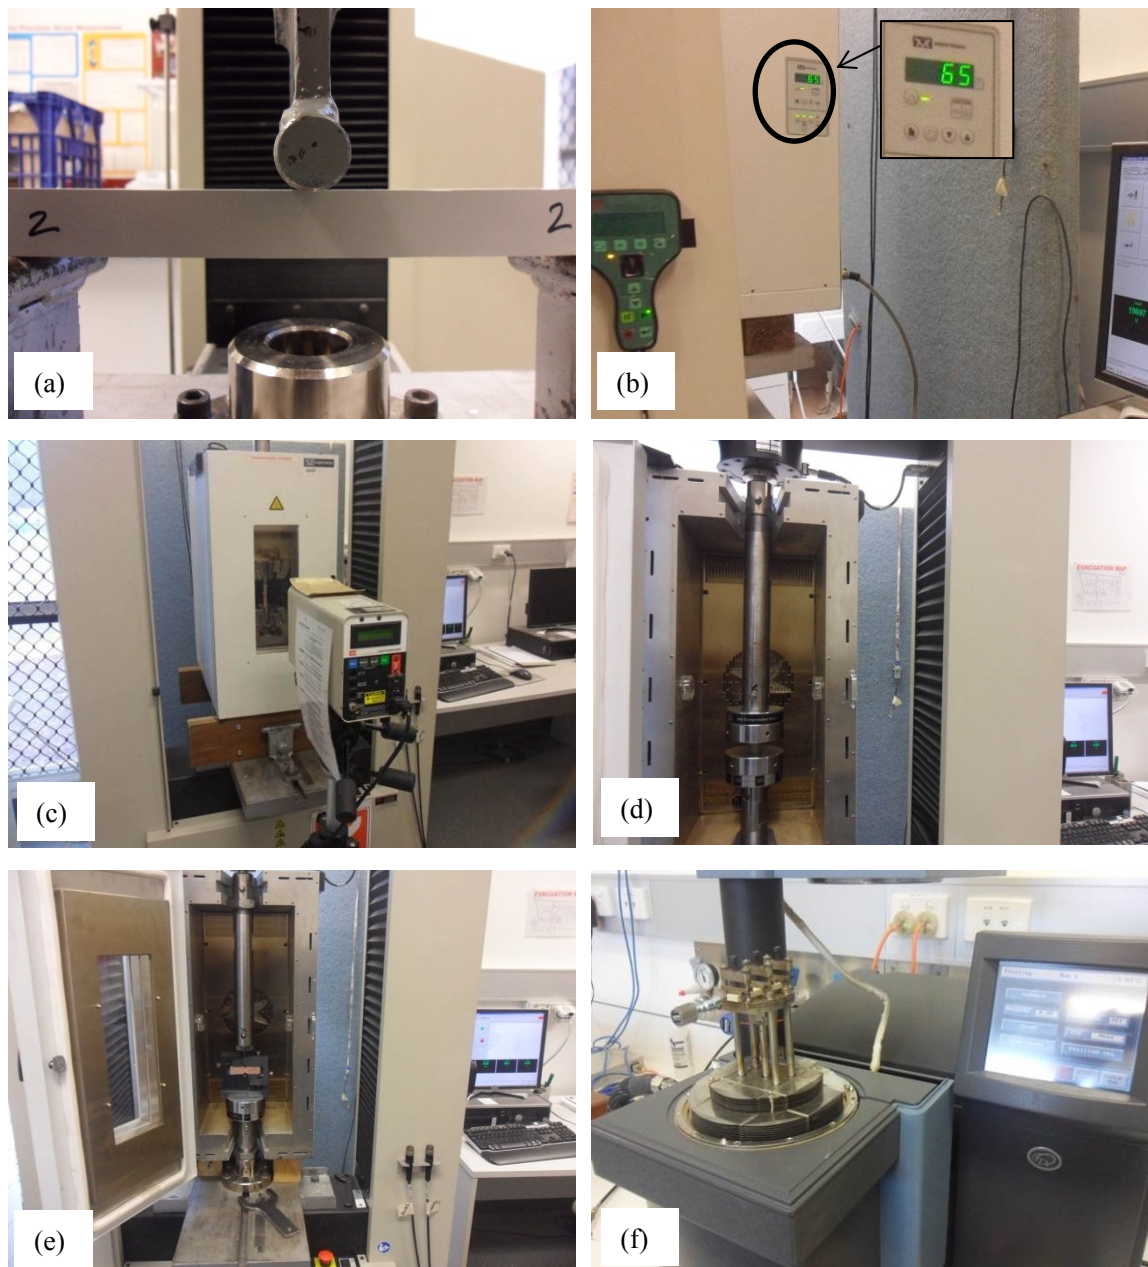
Figure 2. Testing of the grouts; (a) flexural test at room temperature, (b) elevated temperature, (c) tensile test underway at elevated temperature, (d) compressive test setup inside chamber, (e) typical shear test setup inside chamber, and (f) DMA specimen mounted in test machine.

A laser extensometer was used to measure the strain data for tensile test. Iosipescu shear test was carried out using shear test fixture by Wyoming Test Fixtures Inc. at negligible normal stresses. The fixture is such that a condition of pure shear was introduced at the middle of the specimen by applying two counteracting moments. The hot-wet conditioned specimens were preheated in a water bath by placing in an oven for at least 30 minutes prior to being placed into the temperature chamber for testing. The test started once the chamber temperature reached 65 °C and was maintained for 10 minutes. The specimens were tested at 65 °C as it was irrelevant to test them at 70 °C, since the glass transition temperatures for the all the conditioned specimens were found below 70 °C. Moreover, this temperature is within the specified temperature range suggested by ISO/TS 24817.

Dynamic Mechanical Analysis (DMA) was used to determine the glass transition temperatures of the grouts as suggested by ISO/TS 24817. A DMA Q800 with Universal Analysis 2000 V5.1 Build 92 manufactured by TA Instruments was used to carry out the tests. The specimens were clamped in the three-point bending fixture of the DMA apparatus with effective span length of 35 mm. Figure 2(f) shows the mounted DMA specimens on the DMA apparatus. The heating rate was 1°C/min starting from room temperature to 140 °C.

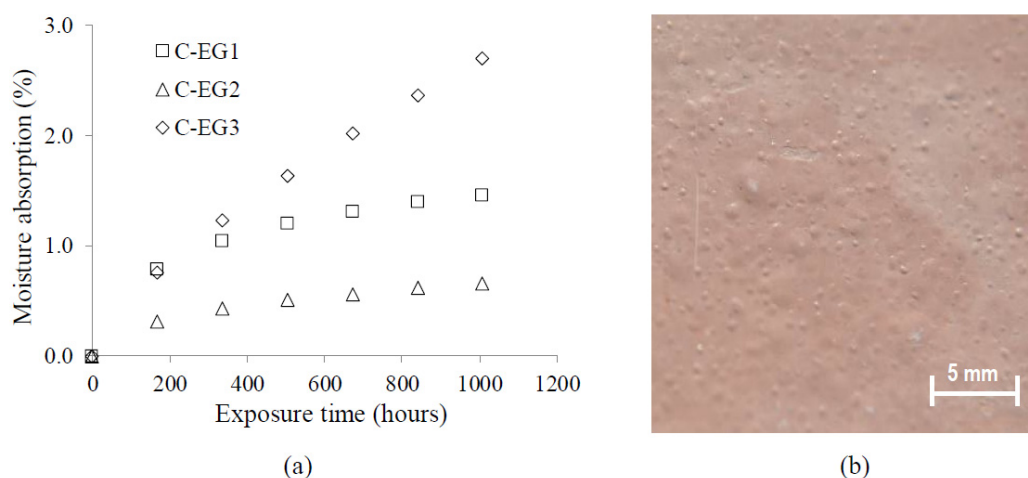
Figure 3. Moisture absorption in grout specimens, (a) Effect of exposure time on absorption, and (b) formation of blisters on grout EG3.

Figure 3 shows the moisture absorption trend of the grouts over the 1000 hours conditioning period. Moisture content is presented against immersion time in hours. The moisture content is calculated for 25 mm cylindrical specimens. If the moisture absorption of the grouts is compared, the highest absorption is observed for grout EG3 with a value of 2.7% after 1000 hours. The trend suggests that EG1 and EG2 grouts reached equilibrium by 1000 hours. However, an increasing absorption trend in the grout EG3 at 1000 hours indicating that 1000 hours may not be sufficient to achieve complete saturation as suggested by ISO/TS 24817. The lowest absorption is found for grout EG2 with values ranging from 0.66%. The trend of the moisture contents of the grouts suggests that absorption rate is the highest during the first 168 hours (7 days) and decreased thereafter for grouts EG1 and EG2, whereas the absorption increases with time for grout EG3. The behaviour is mostly due to the absorption of water molecules in the intrinsic hole volume [15].

The hot-wet conditioning resulted in a mild change in colour on the surface of the grouts. Most notable physical change occurs on the surface of the grout during the absorption process is the formation of blisters on the surface of grout EG3. Formation of blisters on the grout EG3 is shown in Figure 3(b). This might happen due to the swelling forces of the absorbed moisture which forced out of the surface of the specimen.

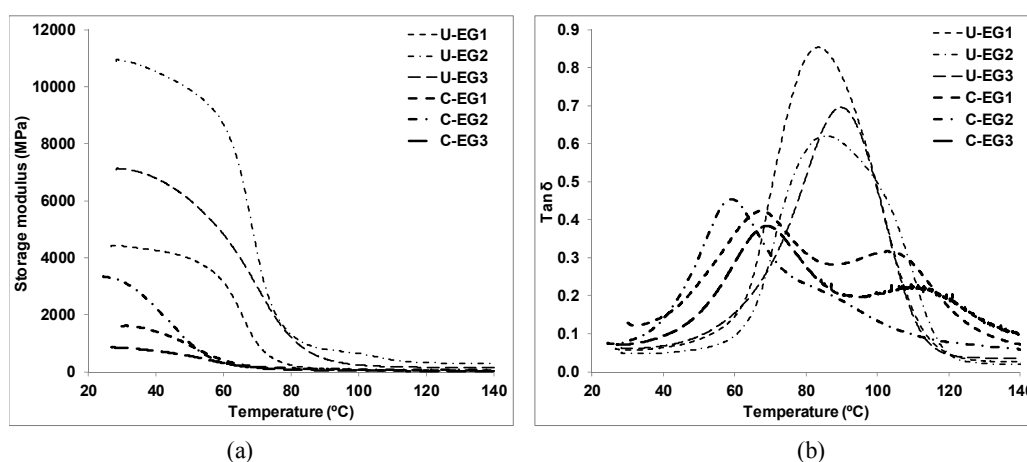
Figure 4. Thermal plots to determine glass transition temperature (a) storage modulus vs temperature, and (b) $\tan \delta$ vs temperature.

A superposition of the storage modulus and $\tan \delta$ is shown in Figure 4. Storage modulus inflexion (T_g) provides lower glass transition than $\tan \delta$ peak (T_i) for both unconditioned and conditioned grouts. This behaviour is also comparable to Goertzen and Kessler [16]. The conditioned grouts show distinct secondary $\tan \delta$ peaks. This phenomena related to exposure to higher temperatures is due to the dominant re-arrangement of the molecules resulting in the formation of much denser crosslinking structure [17].

The T_g and T_i in the unconditioned grouts range between 53–59 °C, and 83–90 °C, which range between 39–42 °C, and 59–69 °C, respectively for the conditioned grouts. The highest value of $\tan \delta$ is observed in the unconditioned grout U-EG3 with a value of 90°C which is found to be 83 °C for grout U-EG1. On the other hand, the highest value of $\tan \delta$ peak is also found in the conditioned grout U-EG3 with a value of 69 °C which is about 2 °C higher than that of grout U-EG1. Hence, the lower resin content in grout EG3 does not reduce its glass transition temperature. However, as the storage modulus was recorded from the room temperature, the tangent of the initial storage modulus could not be drawn. Hence, a horizontal line is considered as the initial tangent line which intersects with another tangent line drawn from the decreasing storage onset to determine the T_g .

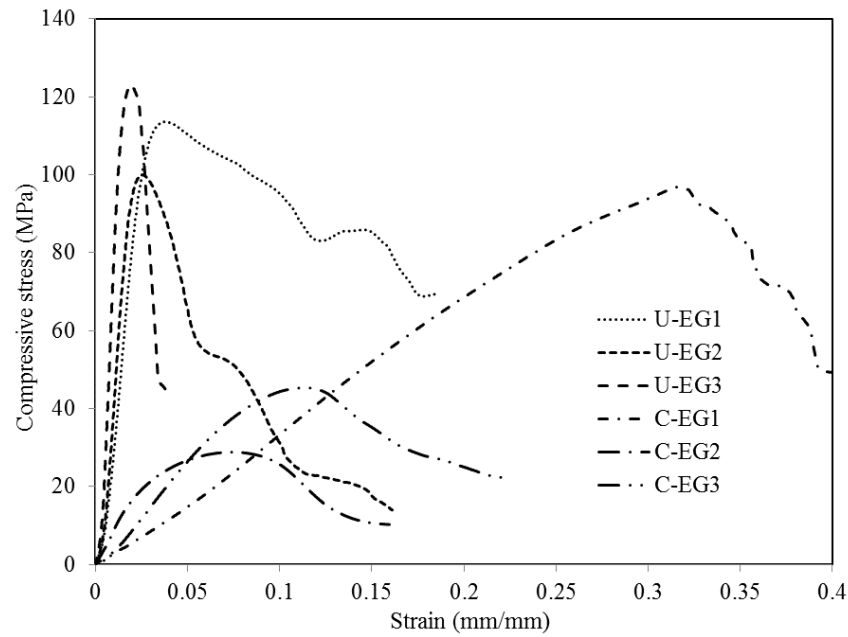
Figure 5. Typical stress-strain behaviour of compressive specimens of the grouts.

Figure 5 shows the comparison of the typical compressive stress-strain behaviour of the compressive specimens. The epoxy grouts show an elastic behaviour followed by yield stresses. The relative deformation in the conditioned specimens are clearly much higher compared to unconditioned grouts. The yield strain of U-EG1, U-EG2 and U-EG3 are 3.4%, 2.3%, and 1.9%, respectively, which increased to about 32%, 8%, and 11%, respectively after hygrothermal conditioning.

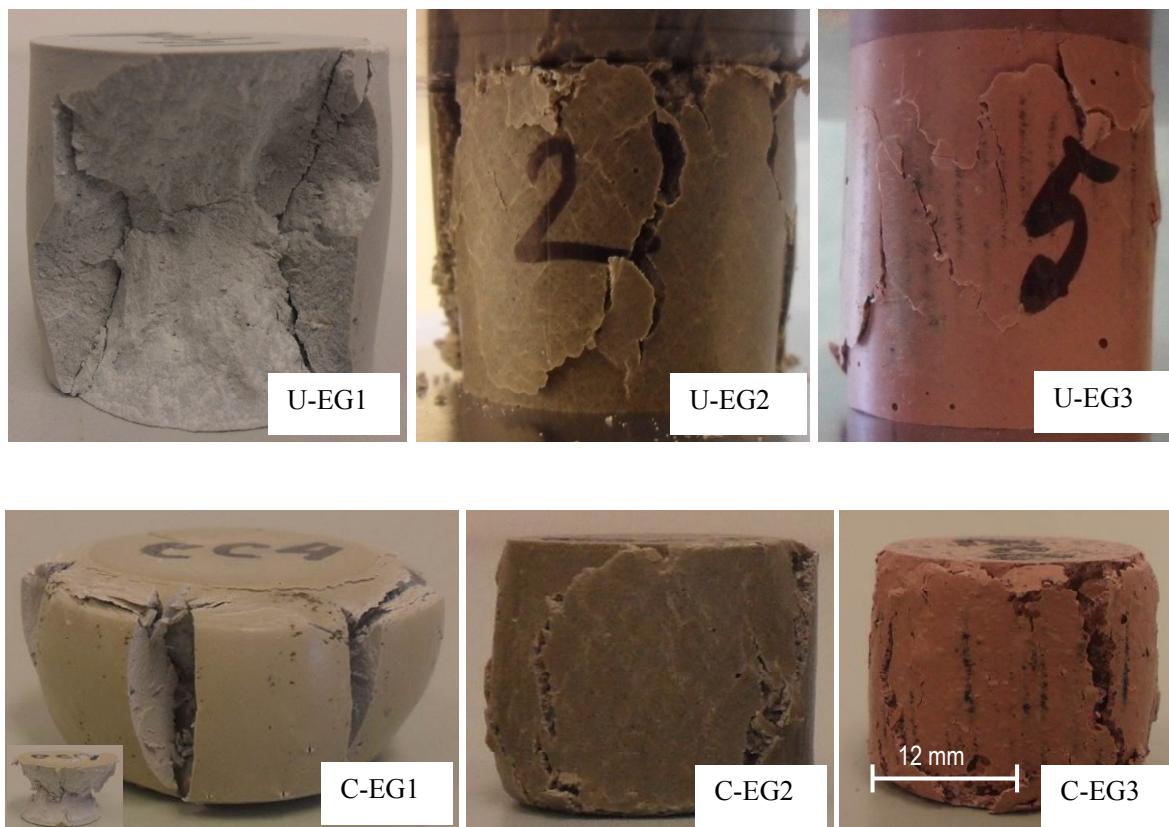
Figure 6. Typical failure patterns cylindrical grout specimens under compression.

Figure 6 demonstrates the typical failure patterns of the unconditioned grouts under uni-axial compression. Under compression, grout U-EG1 exhibits peripheral bulging after the initial elastic behaviour. The orientation of cracks in the outer shell of grout U-EG1 is vertical. District cup-and-cone failure is observed for both U-EG1 and C-EG1 specimens. The bulging proceeds until failure which is initiated by vertical cracks. However, the bulging in the C-EG1 is comparatively higher than that of the U-EG1. The failure wedges in the compression specimens form at an angle of about 45° with the vertical axis for both conditions. The bulging starts after the linear elastic zone of the stress-strain curve. However, for the grout U-EG1, following yield and the accompanying reduction in stress, there is an increase in stress, but not beyond the peak stress. This is due to the meeting of the failure wedges at prolonged strain. The cracks in the grouts U-EG2 and U-EG3 specimens are sharp and randomly oriented with no visible wedge. Similar crack pattern is also visible for the C-EG2 and C-EG3 specimens. However, the cracks are more plastic in appearance indicating cohesion in the surface. The failure is governed by crushing and there is negligible lateral expansion and post yield hardening in the grouts U-EG2 and U-EG3. This behaviour can also be observed in the C-EG2 and C-EG3 grouts, where there is slight bulging and no notable post-yield hardening.

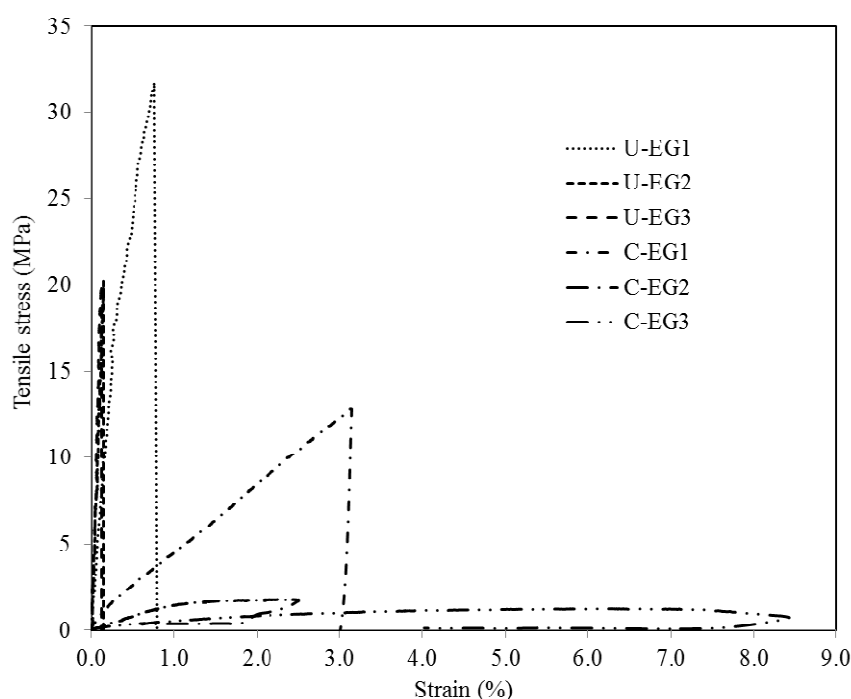
Figure 7. Typical tensile stress-strain behaviour of the grouts.

The comparison of the typical tensile stress-strain behaviour is shown in Figure 7. Unconditioned grout U-EG1 shows relatively prolonged ductile deformation under tensile load exhibiting the highest strength among the grouts. This behaviour may be due to the finer filler in the matrix. Grouts U-EG2 and U-EG3 have moderate strength and the specimens have failed at lower strains than that of grout U-EG1. Conditioned grout C-EG1 shows a linear stress-strain relation exhibiting the highest strength. Grouts C-EG2 and C-EG3 transition to non-linear behaviour almost immediately upon loading, and exhibit very low yield strengths compared to grout C-EG1. The highest failure strain is observed in grout C-EG3. It is to be noted that the tensile strains of the grouts C-EG2 and C-EG3 reverse due to the displacement in the laser reflector tape after the crack formation of the surface of the specimens.

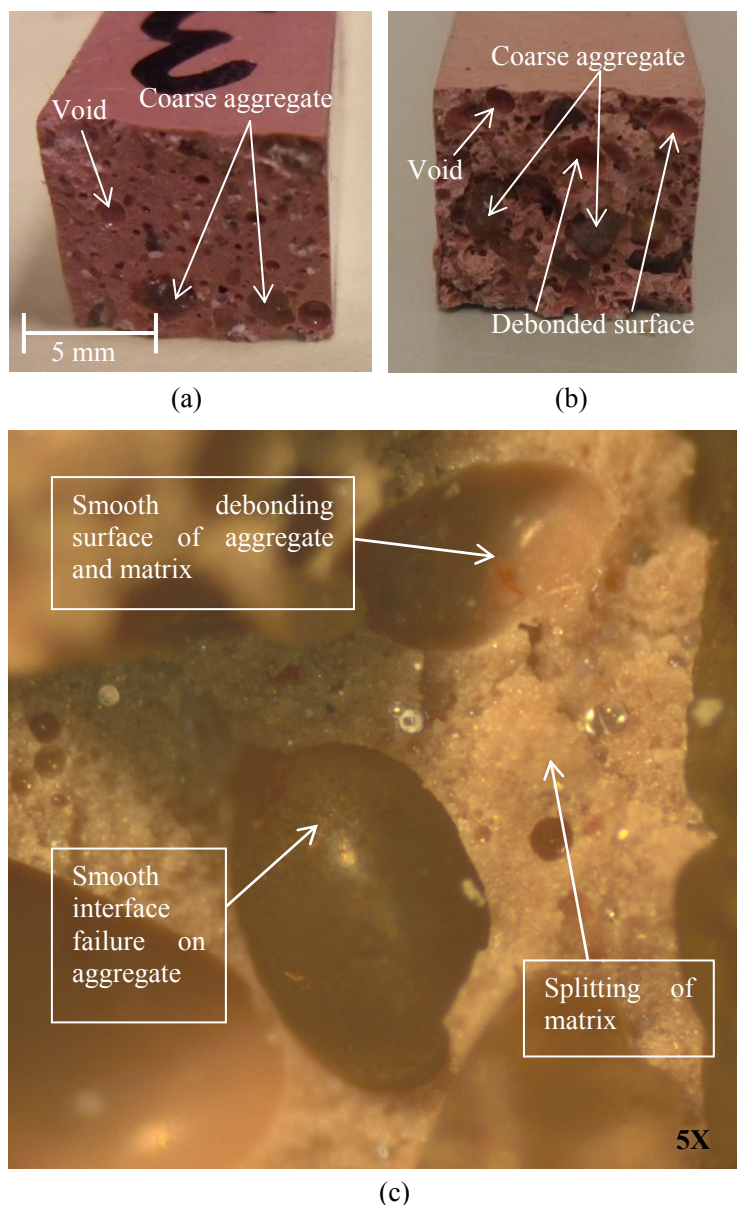
Figure 8. Typical failure surface of tensile specimens of; (a) U-EG3, (b) C-EG3, (c) magnified interface of C-EG3.

Figure 8 shows the typical failure pattern of the tensile specimens. All the unconditioned grouts fail due to splitting, which are perpendicular to the length. The formation of crack in the grouts is sudden and a splitting sound is heard. An observation that can be made is that voids are present in all three cured grouts. The failure surface of grout EG1 has a smooth appearance in both test conditions. The failure surface of unconditioned specimens exhibit smooth texture. Failure surface of the grout U-EG3 is shown in Figure 8(a), which is also representative of U-EG2. It can be seen from the cracked surfaces of the U-EG3 grout that the failure occurs in the matrix through the aggregates. On the other hand, failures in the C-EG3 grout progress slowly compared to grout C-EG1 and are not perfectly perpendicular to the length or straight along the thickness. The failure surfaces of the grout C-EG3 specimens are similar; they appear jagged and the coarse aggregate fillers are visible as shown in Figure 8(b). The magnified view of the failure surface of the conditioned C-EG3 as given

in Figure 8(c) shows that failure occurred in the matrix-aggregate interface unlike the phenomenon in the unconditioned specimens. The interface failure between the resin matrix and the aggregate is due to the effect of hygrothermal conditioning which weakens the interfacial bonding.

The cracked surfaces of both unconditioned grouts EG2 and EG3 show that the failure occurs in the matrix as shown in Figure 8. On the other hand, it can also be seen that debonding of aggregate

and matrix in the conditioned grouts is smooth indicating that interface bonding between aggregate and matrix is weaker than the particle strength of the aggregate. Again, since the matrix itself splits, the resin matrix is weaker than the aggregate particle strength. This behaviour in the conditioned grouts is opposite to the behaviour in unconditioned grouts. Both of these scenarios are described in another study [28]. The failure in the unconditioned grouts is such that the individual aggregate strength is higher than both the resin matrix and the interface bond. The possibility is that the aggregate is strong enough to provide sufficient resistance against failure where the failure occurs thorough the resin matrix and the aggregate, provided the matrix is also stronger than the interfacial bonding energy. In contrast, this situation of conditioned grouts especially grouts with coarse filler align with the argument that the resin matrix, and the matrix-interface bond is weaker than the individual aggregate. From a detailed magnified view of grout EG3 shown in Figure 8(c), it can be seen that aggregates does not split due to tensile force. This implies that hot-wet conditioning reduced the strength of the matrix-grout interface of the grouts.

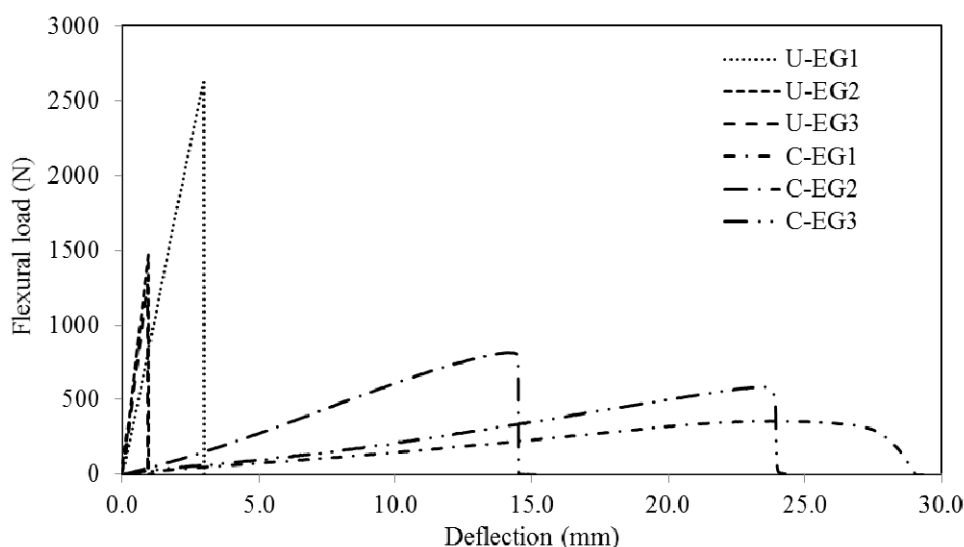
Figure 9. Typical flexural stress-strain behaviour of the grouts.

Figure 9 shows a comparison of typical the load-deflection behaviour of the grout specimens in flexure. The unconditioned grouts show linear load-deflection behaviour prior to failure. Grout EG1 has the highest flexural strength with a value of 53 MPa. Grout U-EG3 has strength of 35 MPa which is lower than grout U-EG1 due to the addition of coarse filler. The flexural stiffness of grouts U-EG2 and U-EG3 is about 13 GPa which is higher than that of grout U-EG1. Conditioned grouts C-EG2 and C-EG3 also showed linear load-deflection behaviour prior to failure, whereas grout C-EG1 exhibits a brief plateau before failure. Grout C-EG2 exhibits the highest load and least deflection prior to failure while grout C-EG1 exhibits the lowest load and highest deflection. As shown in Table 3, despite the intermediate tensile strength and elastic modulus, grout C-EG2 has the highest flexural strength and flexural stiffness, at 19 MPa and 0.53 GPa, respectively. Grout C-EG1, which shows the highest tensile strength and elastic modulus, exhibits the lowest flexural strength and flexural stiffness. This suggests that flexural stiffness of the grouts are considerably affected by hygrothermal ageing.

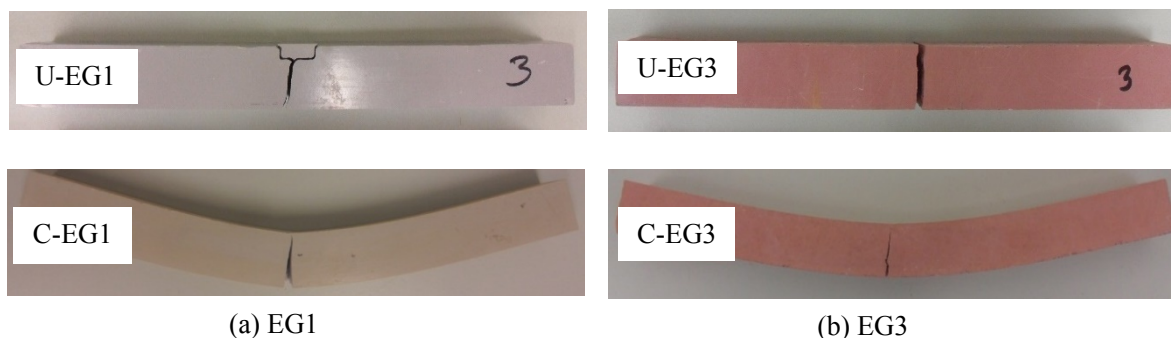
Figure 10. Typical failure pattern of flexural specimens.

The typical failure patterns of the flexural specimens are shown in Figure 10. All unconditioned specimens fail in a brittle manner. The cracks are almost perpendicular to the longitudinal axis for specimens U-EG2 and U-EG3. However, the cracks deviate from its tension zone alignment when they propagate towards compression zone for grouts U-EG1 and compression wedge is formed. Also, inspection of the cracked surface suggests that the failure of the resin matrix propagates through the aggregates. This behaviour is also comparable to the tensile behaviour discussed earlier. On the other hand, all the conditioned specimens undergo considerable deformation before failure as seen from Figure 10(b). The cracks are perpendicular to the length for all conditioned grouts with the compression wedges not apparent from the failure surfaces. Further inspection of the cracked surface revealed that failure of the resin matrix propagates through the resin matrix, and interface of the resin

and aggregate. This behaviour is comparable to the tensile failure behaviour of the conditioned specimens.

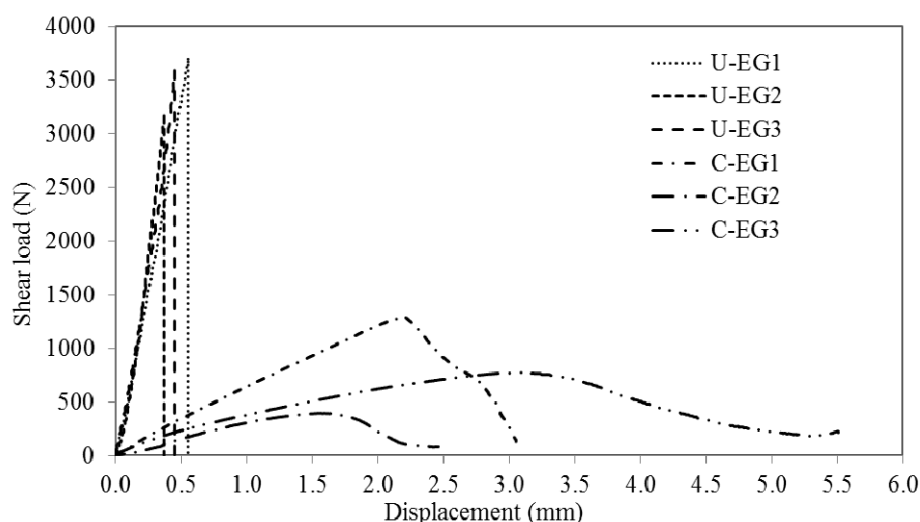
Figure 11. Typical shear load-deflection behaviour.

The shear strength of the unconditioned grouts U-EG1, U-EG2 and U-EG3 are 30, 25 and 28 MPa, respectively while the conditioned grouts C-EG1, C-EG2 and C-EG3 are 10 MPa, 3 MPa and 6 MPa, respectively. Hence, the shear strength is affected adversely due to inclusion of filler. Grout C-EG3 exhibits lower shear strength than that of grout C-EG1. Figure 11 shows the relative comparison of load and crosshead displacement of the grouts under shear loading. Grouts U-EG1, U-EG2 and U-EG3 exhibit linear load-displacement behaviour before distinct reduction in load during failure, which is also applicable for C-EG1. However, grouts C-EG2 and C-EG3 show relatively smooth transition in the load-displacement plot during failure.

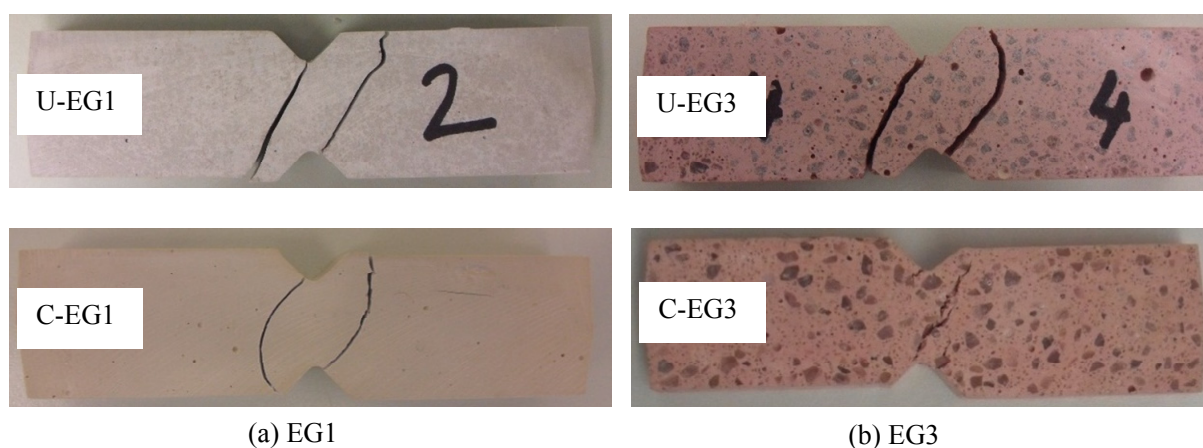
Figure 12. Typical failure pattern of shear specimens.

The failure occurs suddenly after the peak load with no prior warning in all the unconditioned grouts. However, the conditioned specimens undergo considerable deformation prior to failure. The failure is made up of two diagonal cracks and a failure wedge in-between the cracks in the unconditioned grouts as shown in Figure 12. Typically, formation of a shear wedge is observed from one crack running from bottom of the top notch towards the bottom plane surface and the second crack running almost parallel from the top of the bottom notch diagonally towards the top plane surface. Hence, it is evident that the failure in the unconditioned grouts is a combination of shear and tension which was also reported in Iosipescu coupon specimen made of graphite [18]. On the other hand, the conditioned grouts failed gradually after the peak load. The angle of the shear cracks was between 30 and 45°. The failure of the conditioned grout C-EG1 is composed of two diagonal cracks and a failure wedge in-between the cracks is similar to U-EG1. Whereas, the grouts C-EG2 and C-EG3 exhibit one large crack with smaller parallel cracks near the notches at the specimen edges.
